Preparation of atomically flat surfaces on silicon carbide using hydrogen etching

V. Ramachandran^a, M. F. Brady^a, A. R. Smith^a, R. M. Feenstra^a and D. W. Greve^b

^aDepartment of Physics, ^bDepartment of Electrical and Computer Engineering,
Carnegie Mellon University, Pittsburgh, Pennsylvania 15213

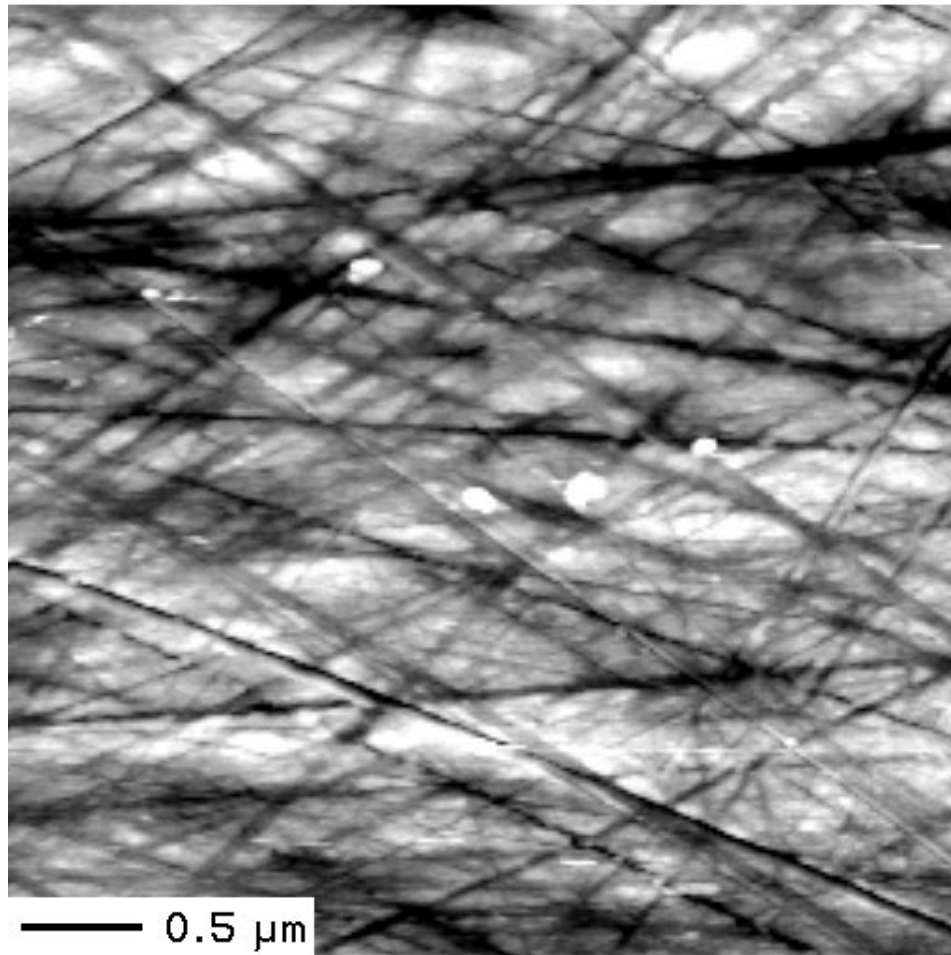
Figure 1 4 μm x 4 μm contact mode AFM image of an as-received 6H-SiC (0001) wafer. 4H-SiC surfaces look similar. Note the high density of scratches on the surface. The greyscale on this image corresponds to a height range of 75 \AA .

The as-polished, solvent cleaned 4H- and 6H-SiC (0001) substrates studied by AFM show a large number of deep (about 75 \AA), irregularly directed scratches all over the surface with breadth in the nanometer range, as seen in Fig. 1. Hydrogen etching at about 1630°C is seen to produce regular arrays of wide (few thousand angstroms) atomically flat terraces separated by steps of unit cell height as can be seen in Fig. [Ref: steps]. (One unit cell of 6-H SiC is 15.12 \AA high in the c -direction, i.e. perpendicular to the (0001) plane. A unit cell of 4H-SiC is 10.08 \AA [5]). The steps are found to lie along the $\langle 1 \bar{1} 00 \rangle$ family of directions. The inset of Fig. 2 shows steps arranged around an etch pit or micropipe, to be discussed in more detail below. The substrates become more transparent with increased etching which we attribute to the diminished number of scratches causing a reduction in the amount of diffuse reflection of light.

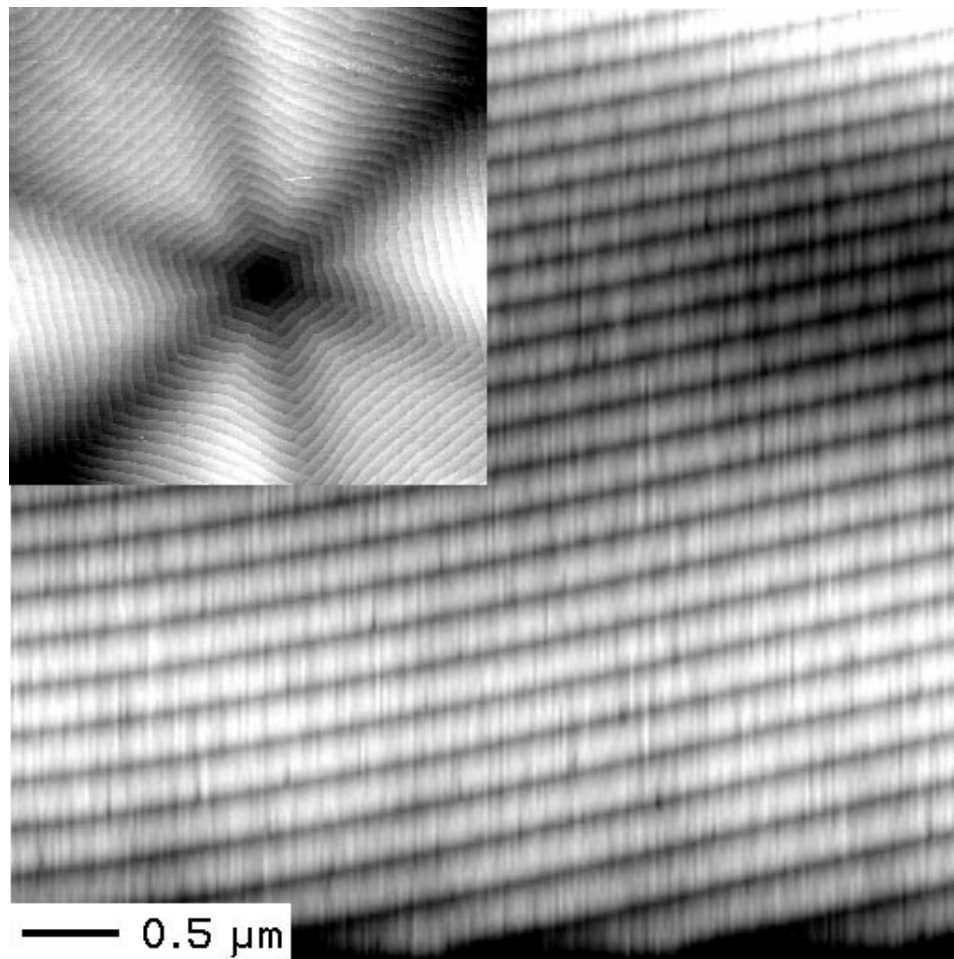
Figure 2 AFM image of a hydrogen etched 6H-SiC (0001) surface. The terraces are about 2500 Å wide and the steps are 15 Å high. The 20 μm x 20 μm inset shows the etched surface of a 4H-SiC wafer. Arrays of steps can be seen on this surface too. These arrays are arranged in a hexagonal pattern around a core that is associated with a 10 Å screw burgers vector. The greyscale ranges for this figure and inset are 5 and 9 Å respectively.

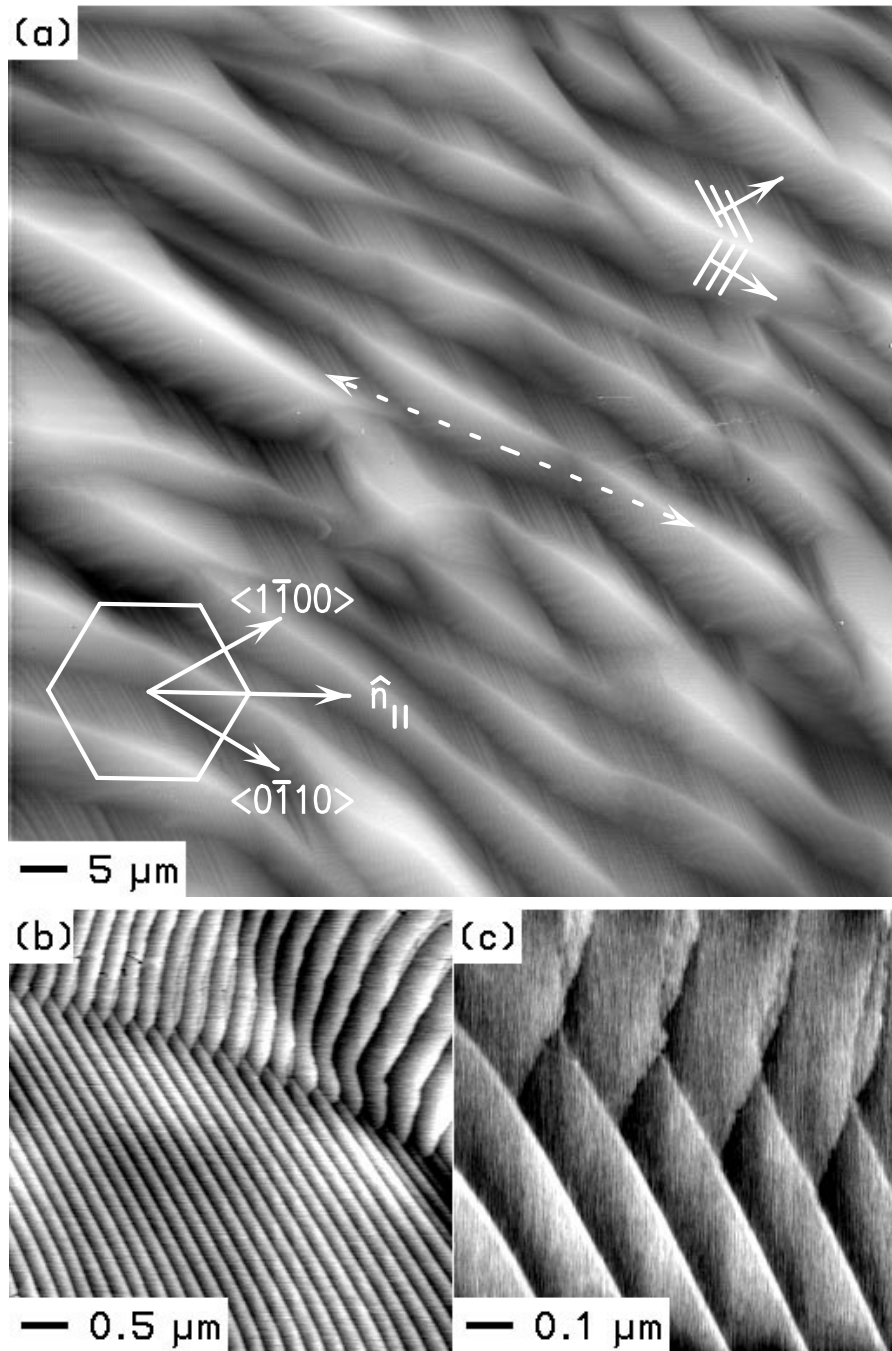
Figure 3 (a) AFM image of a hydrogen etched 6H-SiC (0001) surface showing facets leading to an undulating surface. The faceting arises from the miscut not being directed along a direction in which stable steps exist. Indicated on the image are various step directions on the surface and the (0001) in-plane component of the wafer miscut, $\hat{n}_{||}$. (b) Two arrays of steps intersecting at a facet boundary. (c) Close-up of the facet boundary showing the 60° relationship between steps on neighbouring facets. Greyscale ranges are 236, 15 and 14 Å for (a), (b) and (c).

The surface produced on 6H-SiC(0001) is faceted, and the facets form a shallow undulation (facet angle $\sim 0.1^\circ$) on the surface as shown in the large-scale image of Fig. 3 (a). These shallow facets have been observed to exist on all the samples we have etched. Figures 3 (b) and (c) show the arrangement of steps at the intersection of two facets. Steps on neighboring facets are directed differently: the two sets of steps always have an angle of 60° between them, and they have an offset in height in the (0001) direction of 7.5 \AA . This height is half a unit cell of 6H-SiC and describes the plane in the unit cell where there is a change in the stacking sequence [5,6]. Hence, we conclude that the surfaces of the terraces on the two facets have different orientations. In general, facets with steps directed differently also have different terrace widths, implying that the angle made by these facets with the (0001) plane is different.

Analysis has been done on Fig. 3(a) producing a value of 0.25° for the miscut of the wafer which is well within the specifications of the supplier. The (0001) in-plane component of the miscut is shown as $\hat{n}_{||}$ in the figure. For this sample, this vector is only 2.23° off from the $[1 \bar{2} 10]$ direction.

The calculated direction of the hill-and-valley features is also shown on Fig. 3(a) as a dashed arrow, and is seen to be reasonably consistent with the data.

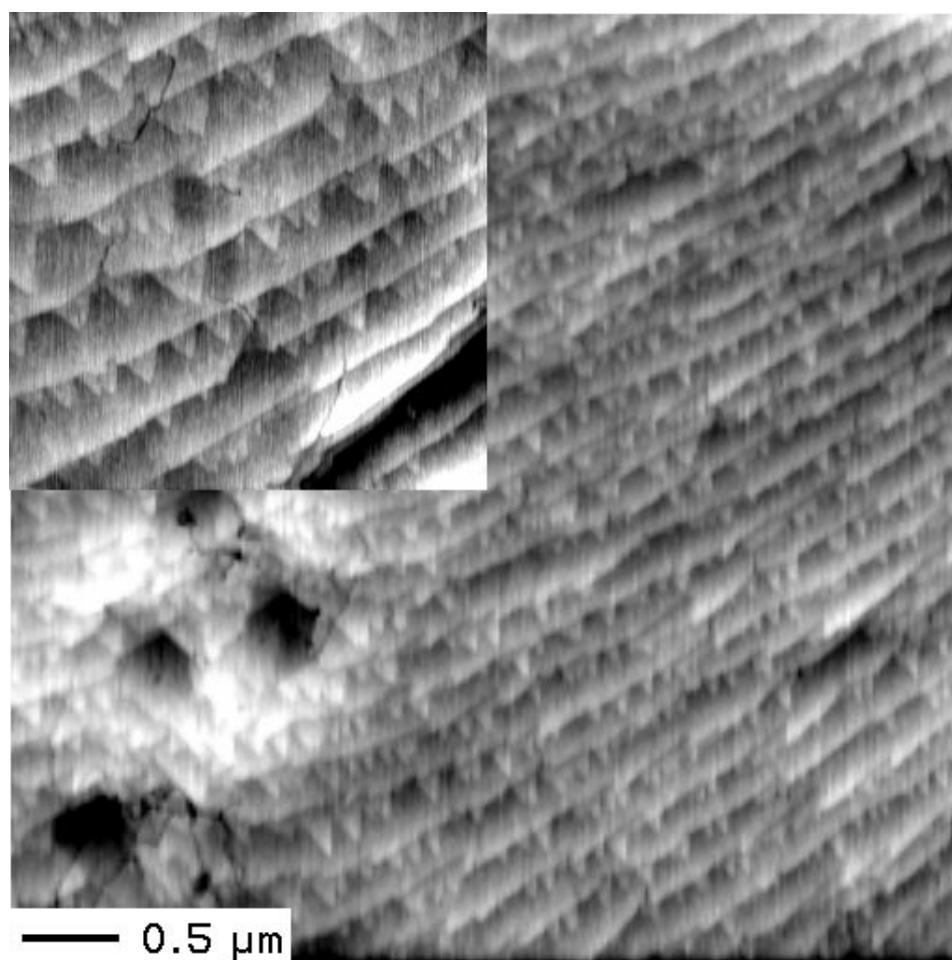
Figure 5 AFM image of an early stage of etching showing rough steps and triangular outgrowths from the steps onto terraces below. Some deep depressions can be seen towards the left which are presumably remnants of deep scratches. The inset is a $2\ \mu\text{m} \times 2\ \mu\text{m}$ close up of a similar area showing the steps and peninsulas in greater detail. Greyscale corresponds to a height range of $15.5\ \text{\AA}$ in the figure and $18.2\ \text{\AA}$ in the inset.

In Fig. 5, we show an atomic force micrograph of a 6H-SiC sample that was hydrogen etched for 1 minute. This is a picture of an early stage of etching. The unit-cell-high steps are seen to be rough. Triangular peninsulas of height half a unit cell protrude from the steps onto the terraces below them. The triangles are observed to have 60° angles at their vertices. These peninsulas can also be understood in terms of “fast-etch” and “slow-etch” directions of the (0001) surface. The etching proceeds in the “fast-etch” direction of one set of bilayers allowing only the more stable steps to survive along one of the slow etch directions. But half a unit cell below (or above), because of the change in stacking, this slow-etch direction becomes a fast-etch direction. Steps in this direction vanish faster leaving behind steps at angles of 60° to it. This leads to the appearance of the triangles with included angles of 60° . The kink at the apex of such a triangle is another instability which leads to preferential etching of these triangles, eventually leaving an array of unit-cell-high steps. The deep depressions seen on this partially etched surface are probably remnants of surface damage that was previously on the surface. Such a surface may later develop into one similar to that in Fig. 6, (which is an area close to that where Fig. 5 was taken) where the depressions have grown smaller and the steps have become smoother. This is expected since if the scratches were made on the surface, they would be widest at the top and as etching proceeds further down, the width of damage should reduce. Eventually the remnants of surface damage vanish entirely leaving surfaces looking like Figs. 2 and 3.

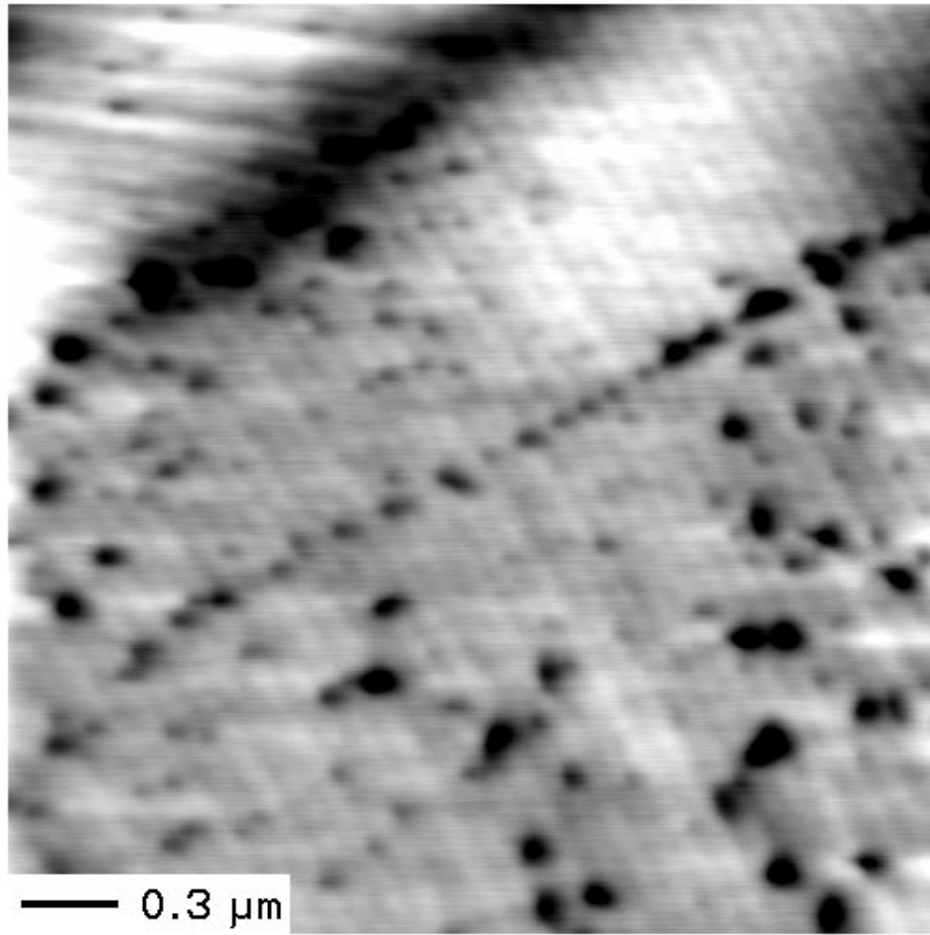
Figure 6 SiC (0001) surface showing incomplete etching. An array of straight, parallel steps is clearly visible. Remnants of scratch marks can be seen as sets of pits arranged in lines cutting across the steps. The greyscale range is 21.2 Å.
